[NONDESTRUCTIVE RESIDENTIAL INSPECTION METHOD AND APPARATUS]

[0002] This invention relates to the field of nondestructive residential inspection.

This invention provides an apparatus for nondestructive residential inspection and various methods for using a thermal imaging apparatus coupled to inspect exterior residential components, interior residential components, a pitched roof and basement of a residential building and the electrical system of a residential building.

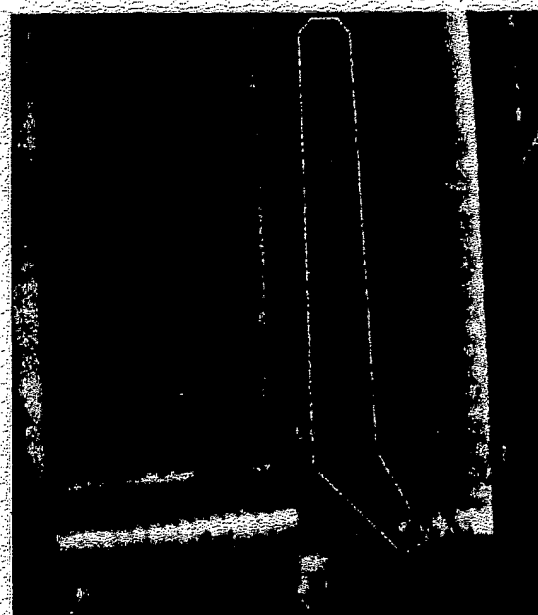
[0028] FIG. 9 is a temperature profile of a brick wall.

[0091] FIGS. 8 and 9 show temperature profile taken at noon. In FIG. 8, no thermal anomalies are present, while in FIG. 9, a thermal anomaly 8 shows a cracked brick wall. This temperature profile shows as a thermal anomaly because moisture is in the crack in the wall.

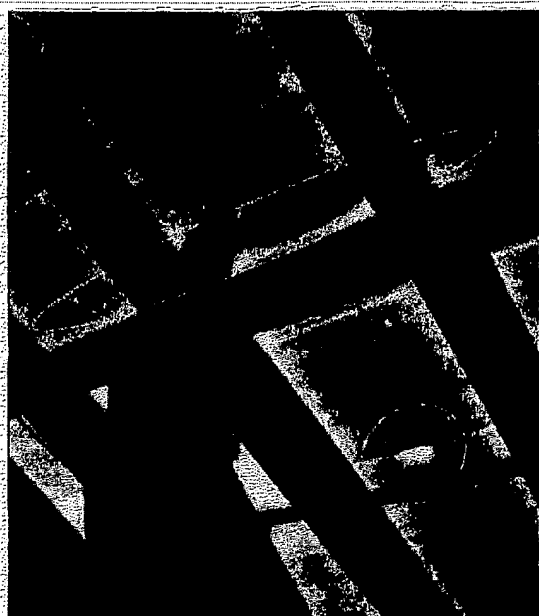
[0031] FIG. 10C is a temperature profile of the interior surface underside of a roof.

[0094] This invention can be applied to pitched roofs to inspect the condition of a residential roof. More specifically, in FIG. 10C the source of a leak can be traced by assessing the thermal anomaly 11. The leak can be followed from left to right to find the leak shown as the dark spot. Additionally, this method can also be used to detect structural deformation. The thermal anomaly shown as the white irregular spot 12 is indicative of a puncture in the roof decking material with the shingles covering over the puncture. This method can also be used to detect structural damage such as cracks. The temperature profile is recorded on a digital recording device.
